De Pauw, Ben Dieter; Hinderdael, Michaël; Moonens, Marc; De Baere, Dieter Jens; Geernaert, Thomas; Berghmans, Francis; Guillaume, Patrick

*Published in:*  
Smart Materials and Structures

*Publication date:*  
2019

# Fatigue failure monitoring of 316L stainless steel coupons using optical fibre based distributed strain sensing

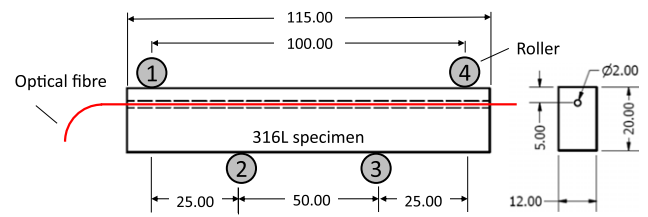
**Figure 1.** Schematic representation of the four point bending set-up and fatigue test specimen with an integrated optical fibre fixed inside a capillary. Dimensions are in millimetres.

All 3 specimens had overall dimensions of 12 mm × 20 mm × 115 mm. Generally speaking, the preferred location for attaching fatigue sensors that rely on strain measurements is the surface of the component where the highest strains are expected. These high strains however, which are expected to cause fatigue damage in the steel component, are also likely to damage said sensors. In addition, a complex engineering component can have multiple surfaces where critical strain levels are expected. It would hence not be very practical or cost-effective to instrument every critical area of the component since the presence of a multitude of surface mounted sensors each requiring some sort of wiring, which in its turn also significantly impacts the handling of the component. Therefore, we opted to demonstrate the use of an embedded optical fibre in the steel specimen. To do so, the 3 steel specimen were equipped with an integrated capillary in which the optical fibre could be embedded, as schematically illustrated in figure 1. This straight 2 mm diameter capillary was drilled using deep-gun drilling through the entire test specimen. Note also that the embedding of the optical fibre appears compatible with the anticipated developments in AM as for example the DED technique could allow incorporating the capillary and even the optical fibre during the actual manufacturing of the sample [24–26].

The capillary is oriented perpendicularly to the principal stress direction for the specimen in the 4-point bending setup. The cross-section of the specimen is uniform across its entire length. The capillary does not introduce local stress concentrations, but only leads to an overall increase of the stress since the load is distributed over a smaller, but uniform, cross-section. It has been shown that the capillary does not act as an initiation site for fatigue damage and that the fatigue properties of the specimen remain unaltered when including such capillaries [29, 30]. A summary of fatigue tests of specimen with and without capillary is shown in table 1 in [31].

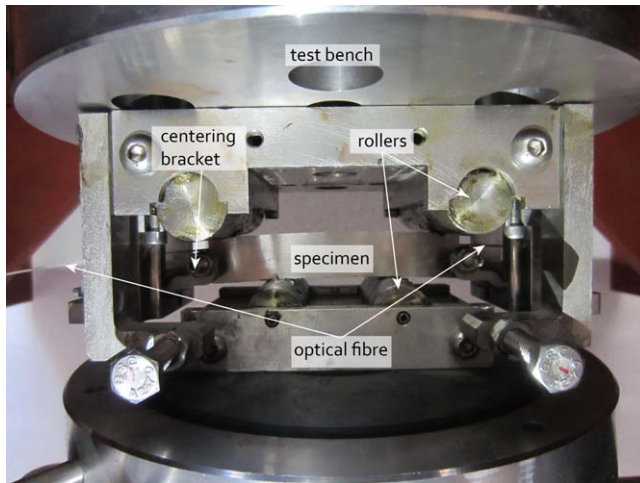
**Figure 2.** Photograph of the four-point bending fatigue test bench with installed specimen and integrated optical fibre.

Figure 2 shows a photograph of the four-point bending fatigue test set-up. The supports consisted of four steel rollers. The top rollers are actuated, whilst the bottom rollers remain fixed. Centring brackets ensured that the specimen were properly aligned in the plane perpendicular to the actuation axis. The diameter of the roller supports was 25 mm. We set the fatigue loading to be a sinusoidal cyclic load at 15 Hz with a stress ratio (*R* ratio) of 0.1. The mean load was different for each experiment and ranged between 12.4 and 24 kN. For each of the tested specimens however, we followed different procedures to promote the occurrence and propagation of a fatigue crack under four-point bending as detailed in the subsequent sections.

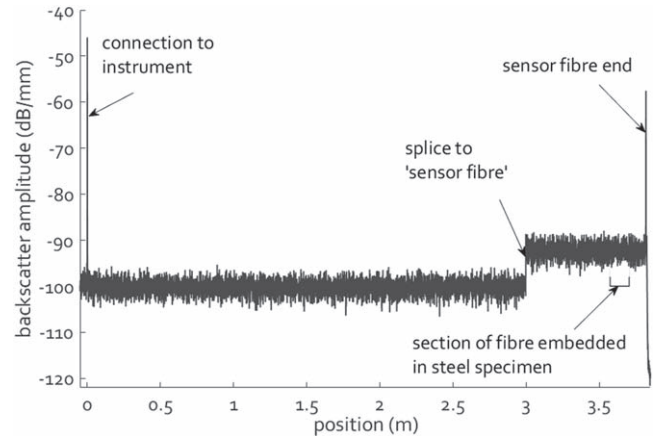
**Figure 3.** Typical response of the optical fibre using the OFDR technique which relies on the scattering losses at every position in the optical fibre that are inherent to the fibre. Local changes in the scattering losses can be linked to local temperature or strain changes.

Figure 3 shows an example of such a fingerprint for the fibre used in the fatigue experiments. In our experiments we used a Luna Innovations OBR 4400 [35]. The fibres had a length of about 3.7 m consisting of a 3.0 m long optical fibre and a 0.7 m section of Ge-doped single mode fibre with 1 mm outer diameter to increase stiffness and to avoid micro-bends that affect the fingerprint. To maximize the signal-to-noise ratio and to obtain the mentioned spatial resolution at the relevant section of the optical fibre, sources of noise such as Fresnel-type reflections at the fibre end-faces should be avoided or reduced as much as possible. In figure 3 such reflections can be found, as expected, at the entrance of the

source and detector (at 0 m) and at the free end-face of the fibre (at 3.7 m). To reduce the reflections from the free end-face of the optical fibre (at 3.7 m), we dipped it in so-called index-matching gel. Such a substance has a refractive index close to the refractive index of the light guiding part of the optical fibre and allows most of the light guided in the optical fibre to escape instead of being reflected back into the fibre. At the other extremity (at 0 m), good coupling with minimal reflections is ensured owing to a FC/APC type connection (typical return loss of  $-55$  dB) and a cleaned, correctly mated connector.

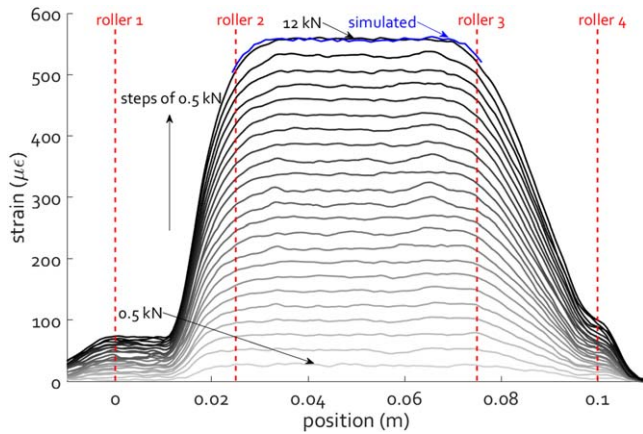
**Figure 4.** Experimentally obtained strain distribution curves (in grey) of a pristine steel (wrought) specimen in the four point bending set-up under different load amplitudes as well as a numerical simulated curve (in blue) for a load of 12 kN. The spatial resolution was 1 mm.

that the rollers need to be cleaned (or even replaced) and lubricated. The four rollers were treated consecutively and the altered strain distribution after each treatment was recorded. Figure 4 shows the corresponding curves. Before the treatment of the rollers, the stress level in the region between the inner rollers showed an important stress difference of  $\pm 12\%$  as compared to the nominal value. Such differences may be sufficient to favour fatigue initiation at the location of highest stress. To validate fatigue test results, it is therefore important to check the stress distribution obtained during practical testing rather than conduct single point measurements. We conclude from figure 5 that the treatment of rollers 2 and 3, i.e. the two inner (or bottom) rollers, yield the most significant effect. After treatment of all rollers, the region of maximum strain between the two inner rollers was constant. This evidences that paying attention to the lubrication of the supports is crucial in such experiments. The overall conclusion of this section is that the distributed strain sensing methodology relying on an embedded optical fibre is a suitable technique to reconstruct the stress profile inside the test specimen and that it can be used to verify whether the test set-up is correctly maintained and operated.

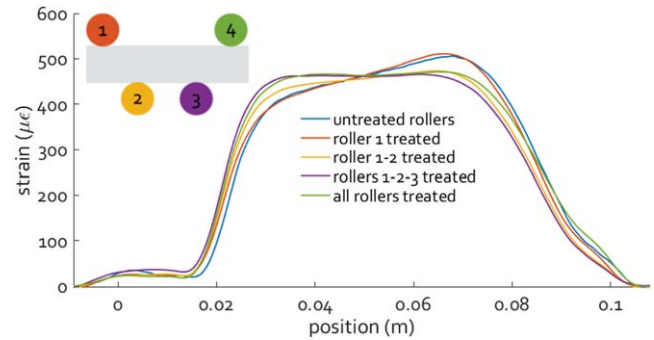
**Figure 5.** The OFDR measurement technique allowed evaluating the quality of the roller supports. Subsequent cleaning and lubrication of the rollers altered the stress distribution inside the specimen, finally resulting in a constant strain distribution between the two central rollers.

An extra feature of the measurement of the shape of the strain distribution curves between the rollers is that this allows evaluating the position of the test specimen and the roller supports of the set-up. In particular, the strain experienced by the specimen should reach a plateau and a maximum in the region between the two inner rollers. However, if one of the rollers is not adequately cleaned and lubricated, the strain measured between the inner rollers will exhibit a slope. To illustrate this, we mounted the reference specimen with embedded optical fibre in the test set-up using 4 rollers that were used in a previous fatigue experiment and showed traces of wear. The blue curve in figure 5 shows the strain distribution that was initially obtained. The presence of a clear slope (with a maximum on the right-hand side) demonstrates

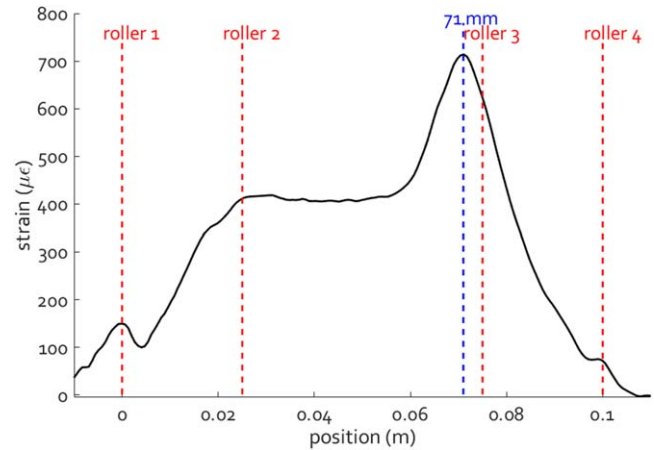
**Figure 6.** The strain distribution observed in the pre-damaged specimen when a static load of 10 kN was applied. We expect the location of high strain concentration at 71 mm to correspond to that of the fatigue crack.

reference ‘fingerprint’ at 500 N. The strain distribution expected from a four point bending set-up remains unaltered, except at a position around 71 mm where a clear strain concentration (i.e. strain hardening) can be observed. As mentioned, the specimen was pre-damaged with the fatigue crack having propagated up to the capillary which leads to a stress concentration at the crack location that can be clearly observed with the optical fibre. We therefore believe that the high strain concentration at 71 mm reveals the location of the fatigue crack. This hypothesis is a conventional approach in case of e.g. imaging techniques (as for example in [9]), supporting to the applicability of our methodology. Note that the fatigue crack must have propagated over the distance between the top surface of the specimen and the capillary, yielding a fatigue crack length of at least 5 mm and a width that is too small to be visualized without microscopes.

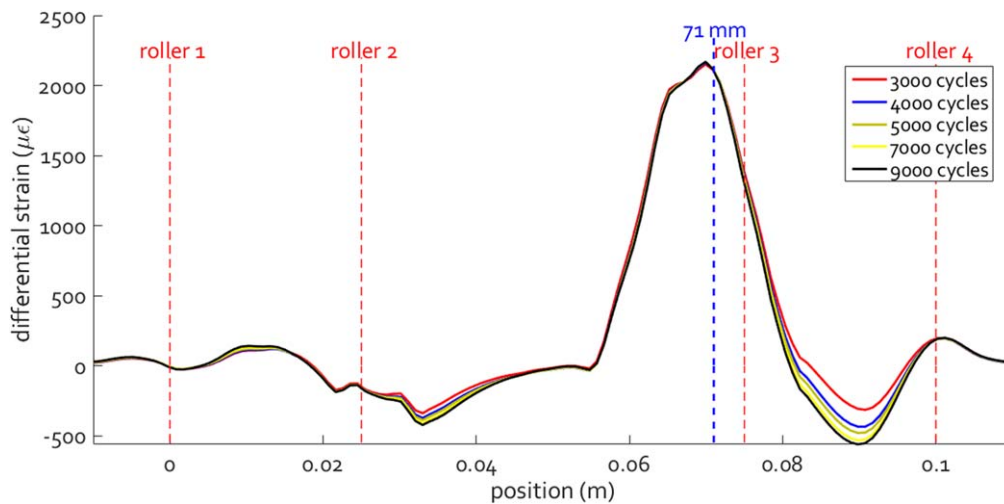
**Figure 7.** The difference in strain compared to the distribution in figure 6 obtained approximately every 1000 fatigue cycles clearly shows the location of the damage at approximately 71 mm. We believe that the observed increase of compression in the vicinity of the damage indicates the growth of the width of the fatigue crack.

current application as the incremental temporal shifts are significantly smaller. The total temporal shift and corresponding strain can then be calculated cumulatively. In addition, relying on the strain difference between consecutive measurements allows (partially) eliminating the impact on the measurements of more gradually occurring effects such as wear of the roller supports (illustrated in the previous section), whilst emphasizing the impact of more sudden strain changes that stem from fatigue damage. We established that growth of the fatigue crack corresponds to a higher stress concentration observed by the optical fibre as illustrated in figure 7 which shows five cumulative strain distributions for different amounts of fatigue cycles. The displayed strain distributions correspond to the total difference compared to that shown in figure 6. The highest change in strain is found close to 71 mm which coincides with the location of the fatigue crack. We observed increasing compression in the vicinity of the crack with an increasing amount of strain cycles and believe that this corresponds to an increase in the fatigue crack width as the crack had propagated already from the surface to the capillary and optical fibre.

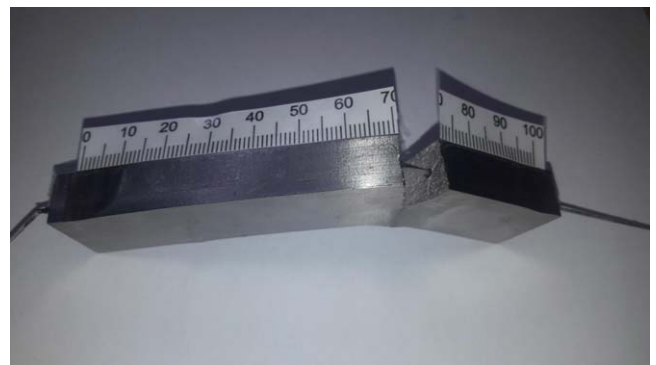
**Figure 8.** The location of the fatigue crack is measured to be 71 mm away from outer roller 1.

After approximately 10 000 cycles, the fatigue crack had grown to a visible fracture as shown in figure 8. The location of the fracture corresponded to the anticipated location at 71 mm. Note that upon fracture (and continued loading) the optical fibre remained intact and still allowed recording the backscatter profile (see figure 9). This indicates that our fibre assembly and mounting method allows for continued measurements at other locations in the specimen even when the latter failed.

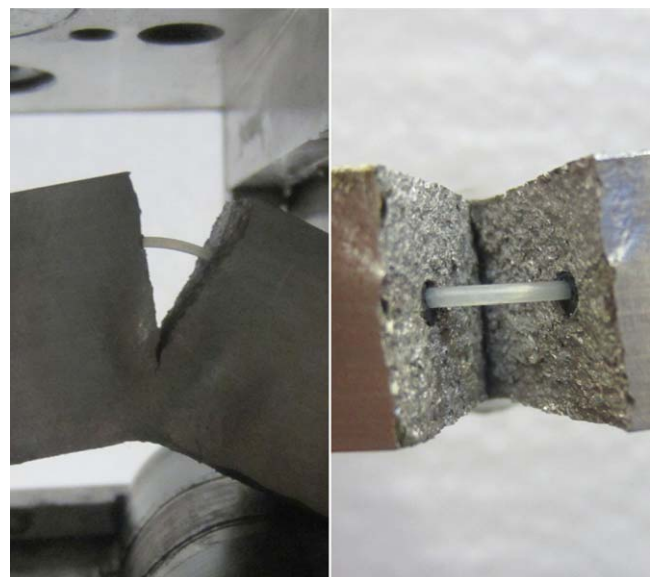
**Figure 9.** Upon further fracturing of the steel specimen, the embedded optical fibre was revealed and proved to be intact.

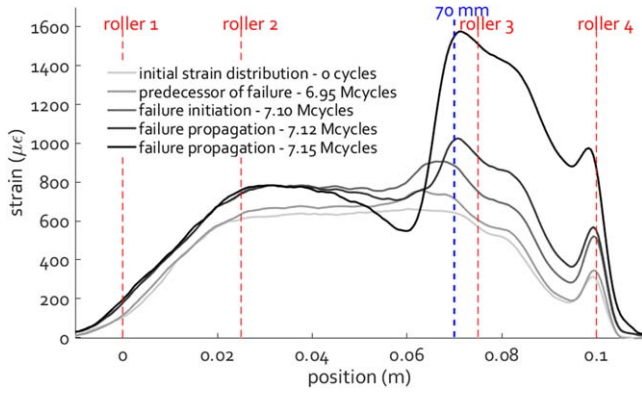
**Figure 10.** Evolution of the strain distribution in the steel specimen obtained during the blind test. The fatigue-induced crack formation, propagation and location are clearly observable. We visually determined location of the damage at 70 mm, indicated in the figure in blue.

Figure 10 shows the strain distribution at 5 different instances during the fatigue test. We determined the strain distributions by comparing a 500 N reference to a static load of 12.4 kN. Initially, at 0 fatigue cycles, the strain distribution corresponds to the curve expected in a four point bending set-up. Slight wear of the four-point bending rollers may be responsible for the small slope at the maximum strain plateau. Up to 6.95 Mcycles, the strain distribution remained essentially constant, except for a small amount of strain hardening. To further facilitate the occurrence of fatigue damage, the size of the notch was approximately doubled on one of the top edges of the specimen after 6.95 Mcycles and the roller supports were rotated. At 7.10 Mcycles i.e. 150 kcycles later, a small strain concentration appeared similar to that observed in the specimen tested in the previous section albeit with a smaller strain amplitude. This indicates that fatigue induced cracks are present in the specimen and are growing. The location of this fatigue damage appeared at around 70 mm. In the two subsequent curves at 7.12 and 7.15 Mcycles, the size of the damage grew quickly until failure of the steel specimen. The rupture location exactly corresponds to the anticipated location i.e. the location of the notch and the location of the precursor of damage in the strain distribution curves.

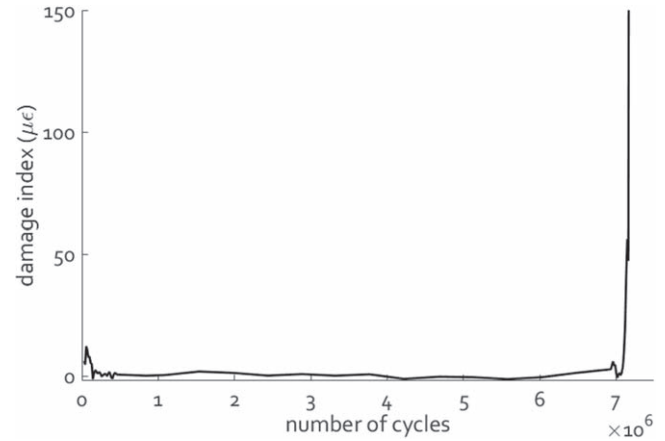
**Figure 11.** Evaluation of the damage index as a function of the number of applied fatigue cycles. Shortly after 7.10 Mcycles, fatigue damage began to propagate.

parameter or figure of merit that can be calculated and used to alert a user for the presence of fatigue damage based on an OFDR measurement. We therefore defined a damage index (DI) that can be calculated from the differential strain distributions i.e. the correlation of two consecutive backscatter profiles to determine the local change in strain. This also allows avoiding gradual changes resulting from the degradation of the roller supports and eliminating the need to calculate the cumulative strain from all the previously measured differential strain distributions. We define this DI as,

$$DI \equiv \frac{1}{A * L} \sum_{k=1}^N (|\Delta \epsilon_k| * l_s), \quad (1)$$

where  $\Delta \epsilon_k$  is the differential strain determined from two consecutive backscatter profiles at position  $k$  with  $N l_s \equiv L$  the total analysed length of the optical fibre, which equals 140 mm.  $l_s$  thus corresponds to the 1 mm spatial resolution of the measurement. This suggested DI is particularly useful to evaluate a section of uniform strain such as the area between the inner rollers in the four-point bending set-up. In a different application, a different DI may be more suitable. Furthermore and depending on the application, a user can define an adequate threshold for the DI and normalize using  $A$  to enable real-time damage monitoring and potential failure prediction. In our case for example, the DI could be normalized with respect to the observed strain at the plateau. Such a normalization would imply that gradual changes in load conditions (e.g. when the applied load is not constant over time) or temperature fluctuations that occur on a time-scale longer than the time between two measurements are rendered negligible. Since the applied loads during measurements were the same during the entire test campaign and the observed temperature changes were small, we nevertheless opted not to normalize the DI in this paper and we kept  $A = 1$ . Figure 11 shows the DI, calculated according to equation (1) of the tested specimen as a function of the number of applied fatigue cycles. The measurements up to around 130000 fatigue cycles show that the DI is between 5 and 12  $\mu\epsilon$ . We believe that this stems from the plastic deformation that occurs at the location of the

rollers as these tend to compress and indent the specimen during the first cycles. Up to about 6.95 Mcycles, the DI remained close to  $0\text{--}3\ \mu\epsilon$ . As mentioned earlier, the occurrence of fatigue damage was facilitated by increasing the size of the notch on one of the top edges of the specimen after 6.95 Mcycles and rotated the roller supports. The latter led to a small increase in the DI to about  $8\text{--}9\ \mu\epsilon$  which again normalized after approximately 100 000 cycles. Close to 7.10 Mcycles, shortly after the modification of the notch, the DI began to increase and continued to increase during more than  $1 \times 10^5$  cycles until the test specimen failed. For the sake of legibility, the vertical axis of figure 11 is limited to  $150\ \mu\epsilon$ , but note that the DI continued to increase far beyond  $1000\ \mu\epsilon$ . This shows that such DI can be a clear indicator for damage detection based on OFDR measurements.

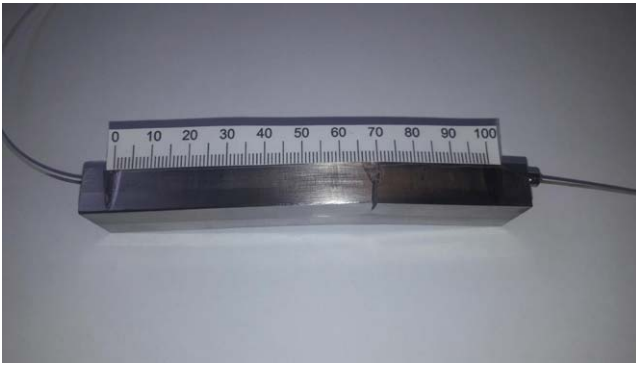
**Figure 12.** After approximately 7.20 Mcycles, the fatigue crack was clearly visible and located at 70 mm from outer roller 1.

Figure 12 shows the fractured specimen. Note that the optical fibre again remained intact after more than 7.20 Mcycles, confirming the robustness of the applied mounting method and the ability to continue measurements across the rest of the specimen.
